Laurence FOUILLAND-PAILLE, Mohamed EL MANSORI - Experimental study of the brittle–ductile transition in hot cutting of SG iron specimens - Journal of Materials Processing Technology - Vol. 213, n°2, p.201-213 - 2013

# Experimental study of the brittle–ductile transition in hot cutting of SG iron specimens

The present paper investigates the brittle-ductile transition (BDT) of the primary shear zone during cutting of spheroidal graphite (SG) iron in the austenitization temperature range (around 1000 °C). The experimental tests were performed using a cutting test bench in the cutting speed range of 0.8 to 1.6m.s<sup>-1</sup>. The cut surfaces were studied using optical microscopy and Scanning Electron Microscope (SEM) analysis techniques. The obtained results revealed either consequent deep fractured regions governed by a brittle-cracking regime (BCR) or a crack-free cut surface governed by a ductile-shear regime (DSR) with large plastic deformations.

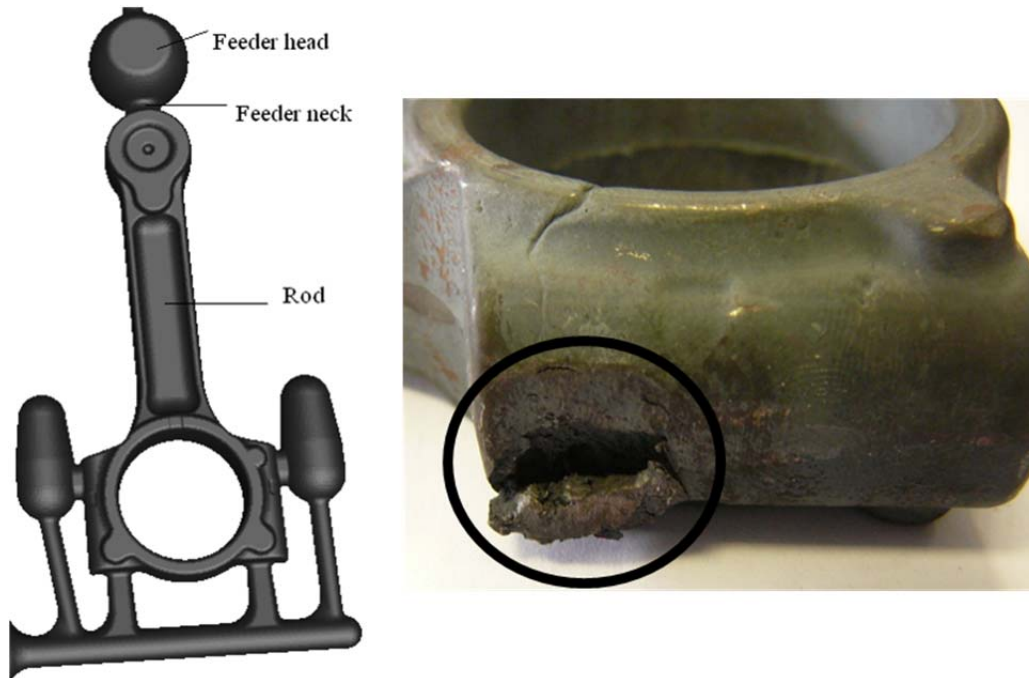
Figure 1. Cast rod before and after the hot spruing operation which causes a well-seen deep cracking damage (surrounded zone).

The spruing operation consists in freeing the rod from its feeder heads by shearing the feeder neck zone under a blanking process. In the mass production context and to keep competitive manufacturing costs, spruing is performed at about 1000°C, just after the casting operation without any cooling between casting and forging. At this temperature, SG iron is in the range of stability of the austenite phase. According to previous studies (Mirzadeh and Najafizadeh, 2010) and due to the low stacking fault energy of austenite, the major restoration process during hot deformation is dynamic recrystallization. In fact, the low stacking fault of the face centered cubic structure such as the austenite promotes most of the lattice dislocations to dissociate into partials. This in turn, severely restricts dislocation cross-slip and dynamic recovery which can balance work hardening. The kinetics of dynamic recovery is low and the dynamic recrystallization can rather initiate.

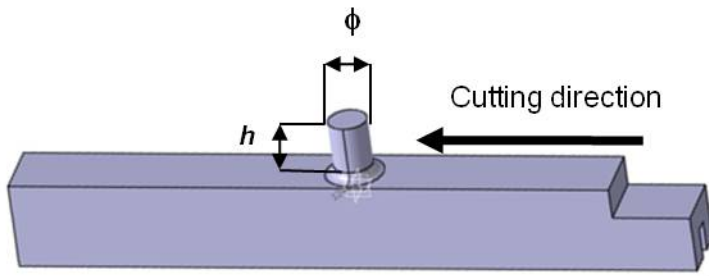
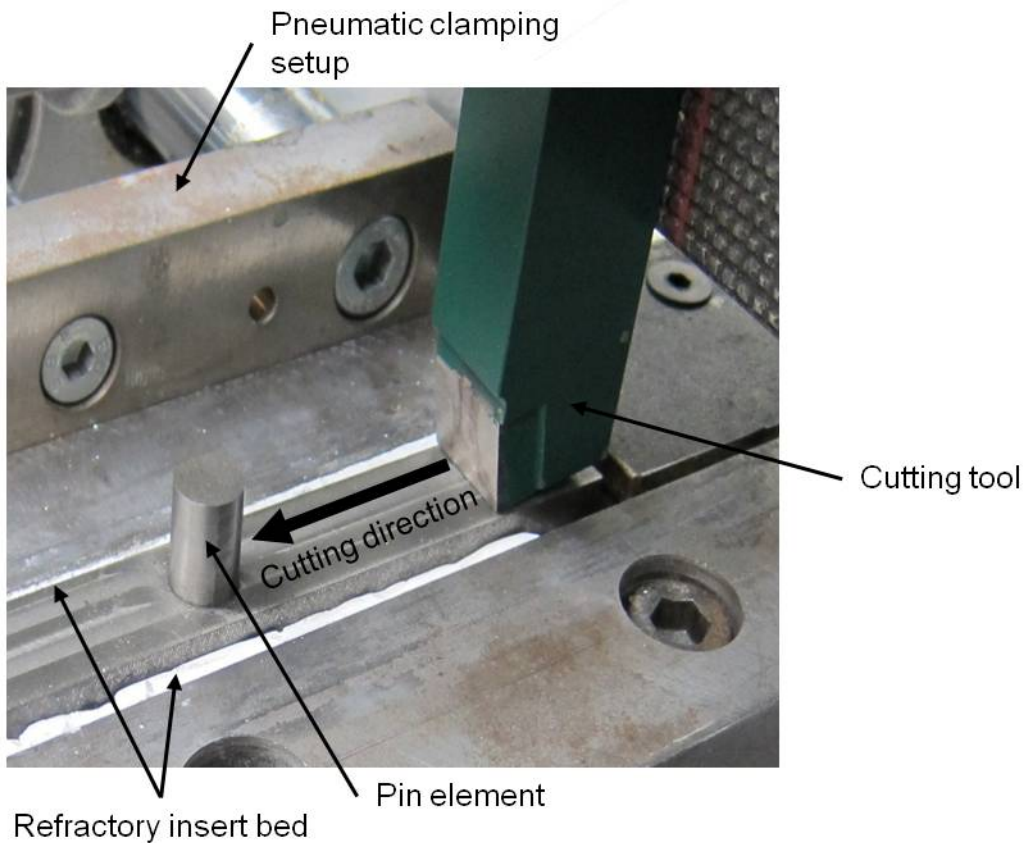
The SG iron specimens consist in machined cast blocks with a pin element of a diameter  $\phi$  and a height h which is entitled to reproduce a partly feeder neck (figure 2a).

Figure 2. Hot cutting test arrangement:

The dimension  $h$  is of the same order of magnitude as a typical depth of cut while the dimension  $\phi$  is made correspond to a representative shear plane length. The specimens are austenitized at  $1000^{\circ}\text{C}$  for ten minutes before the hot cutting process. The clamped specimen into a planning machine and the tool is shown in Fig. 2b. The clamping setup has been manufactured such as two pneumatic cylinders allow a rapid clamping of the specimen, and a bed of refractory inserts

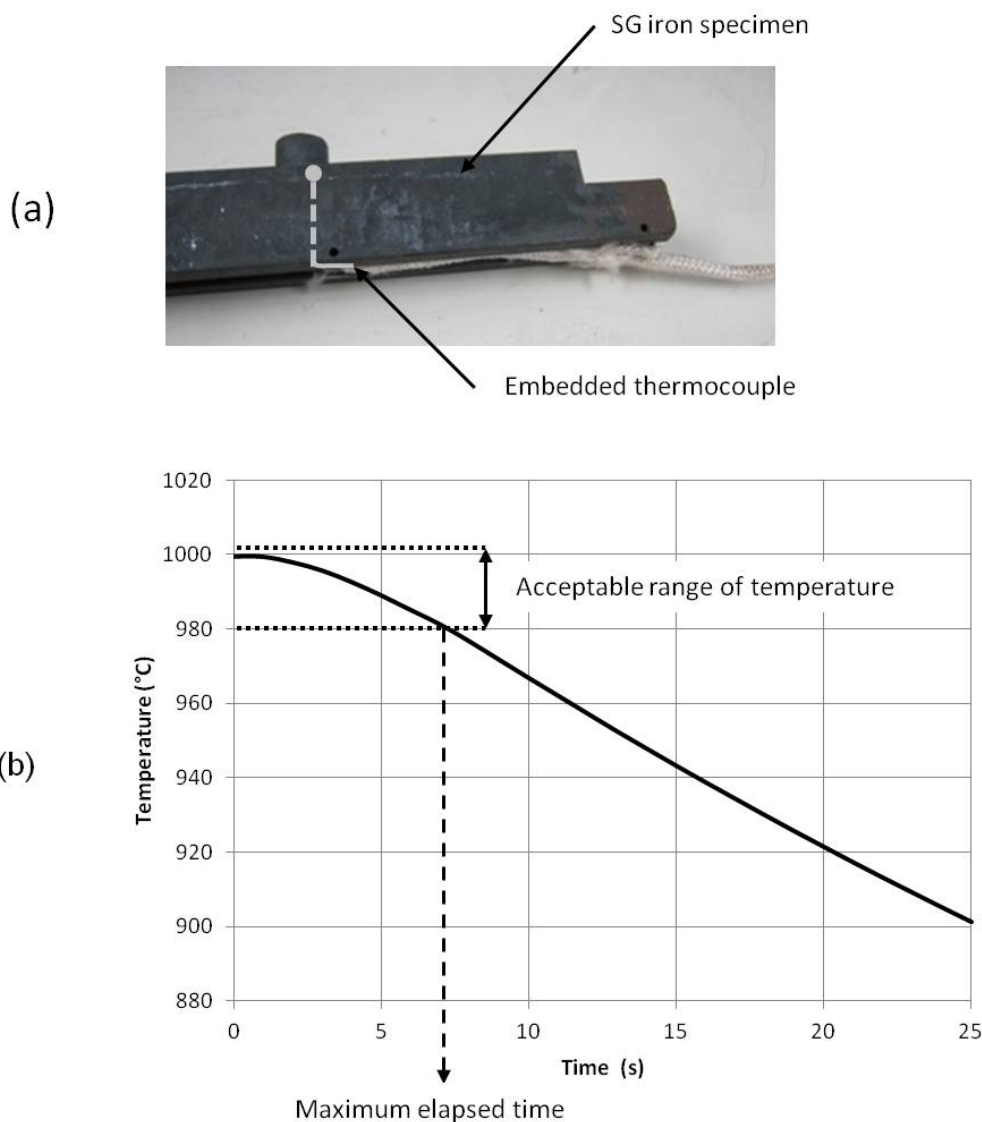
Figure 3. (a) Temperature measurement obtained thanks to an embedded thermocouple; (b) Temperature variation in a heated specimen during cooling into the clamping setup.

prevents heat losses. Indeed, the SG iron specimen must stay in the (austenitization temperature range) range of stability of the austenite phase during the cutting operation (i.e. between 980 and 1000°C). To evaluate the “available time” to perform the test with this condition fulfilled, thermocouples embedded in cutting specimens (Figure 3(a)) have been used to measure the loss of temperature between the take-out of specimen from the furnace and the beginning of the cutting test. Figure 3(b) shows the temperature decrease with time. According to this curve (Fig. 3b), the elapsed time must not exceed seven seconds. Consequently, the experimental tests have been systematically performed under the required conditions.

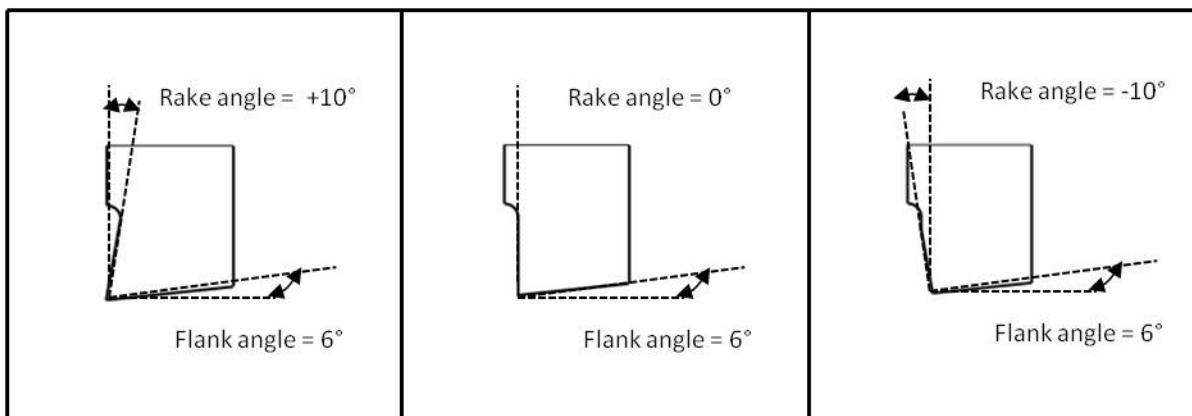
Table 2. Cutting tools geometry.

The orthogonal cutting tests has been performed at three different cutting speeds ( $0.8\text{m.s}^{-1}$ ,  $1.3\text{m.s}^{-1}$  and  $1.6\text{ m.s}^{-1}$ ) with three various rake angles ( $+10^\circ$ ;  $0^\circ$  and  $-10^\circ$ ) using high speed steel (HSS) tools (flank angle =  $6^\circ$ ). The cutting tools geometry is detailed in Table 2. The choice of such experimental variables has been guided by the processing conditions of SG iron rods and limited by the test bench capabilities. Moreover, three various heights  $h$  of the pin element (5 mm, 10 mm and 15 mm) and three diameters  $\phi$  (5 mm, 7.5mm and 10mm) have been tested.

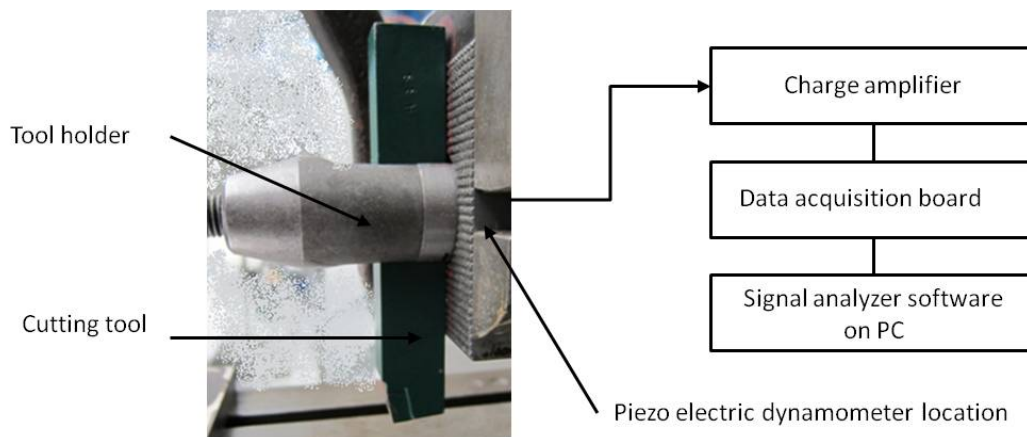
The cutting force in the cutting direction has been measured using a KISTLER piezoelectric dynamometer (type 9104A) mounted on the tool holder (Fig. 4). By the piezoelectric technology, when subjected to a cutting load, quartz produces an electrical charge proportional to the load.

Figure 4. Description of the force sensor setup

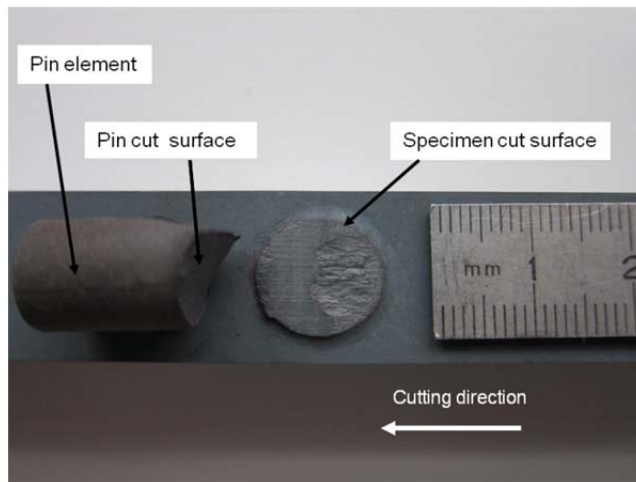
Figure 5. Photograph of the machined specimen showing the cut surface of both the base specimen and the pin element.

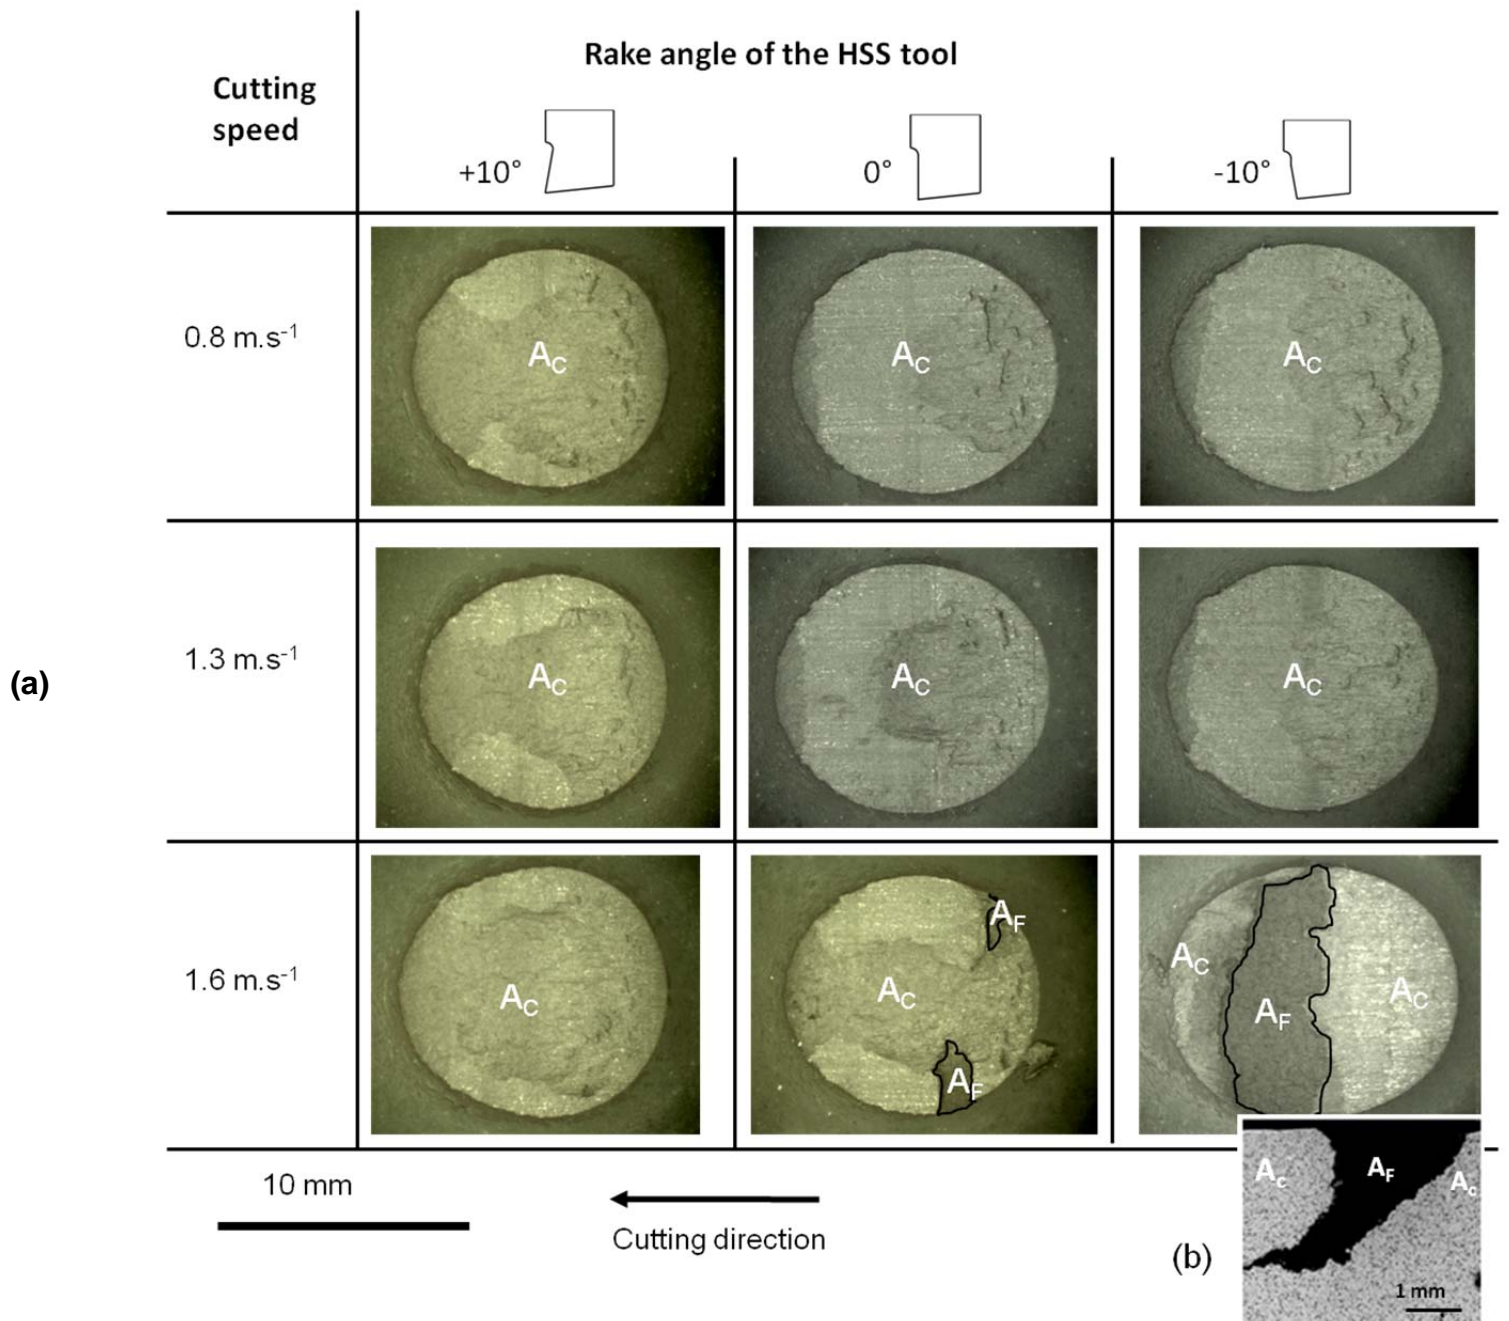
Figure 6(a) shows optical micrographs of the cut surface of the specimen ( $h= 15\text{mm}$  and  $\phi =10\text{mm}$ ) for different cutting conditions. At low cutting speeds ( $\leq 1.3\text{m}\cdot\text{s}^{-1}$ ) irrespective of the tool rake angle, pin elements are completely and nearly perfectly cut, showing a whole quasi flat cut area (referred to as  $A_C$ ). For the highest cutting speed ( $=1.6\text{ m}\cdot\text{s}^{-1}$ ) and the rake angles of  $-10^\circ$  or  $0^\circ$  (tests respectively named as  $1.6\text{ m}\cdot\text{s}^{-1}_{-10^\circ}$  and  $1.6\text{m}\cdot\text{s}^{-1}_{0^\circ}$ ) the aspect of the cut surface becomes heterogeneous: a fractured area (referred to as  $A_F$ ) showing deep cracking (typical depth of a few millimeters) highlighted on figure 6(b) appears within the cut area  $A_C$ .

Figure 6. Optical views of specimen cut faces after hot cutting tests versus to the rake angles of the HSS tool and the cutting speeds tested ( $h=15\text{mm}$ ;  $\phi=10\text{mm}$ ). (a) Cut and Fractured areas are respectively named  $A_C$  and  $A_F$ . (b) Typical cross section view highlighting deep cracking in  $A_F$ .

Two distinct trends can be identified from the first set of tests:

- The fracture propensity increases with the decrease of the rake angle;
- The fracture propensity increases with the increase of the cutting speed.

Clearly here, cutting parameters, which are the most influencing (in terms of presence and span of the fractured area in the cut surface) are those with a negative rake angle ( $-10^\circ$ ) associated with the highest cutting speed ( $1.6 \text{ m.s}^{-1}$ ). Consequently, all other pin diameters (5 mm, 7.5 mm and 10 mm) and pin heights (5 mm, 10 mm and 15 mm) have been tested under this cutting condition ( $1.6 \text{ m.s}^{-1}$  and  $-10^\circ$ ) to investigate the influence of dimensional characteristics on the cutting surface morphology.

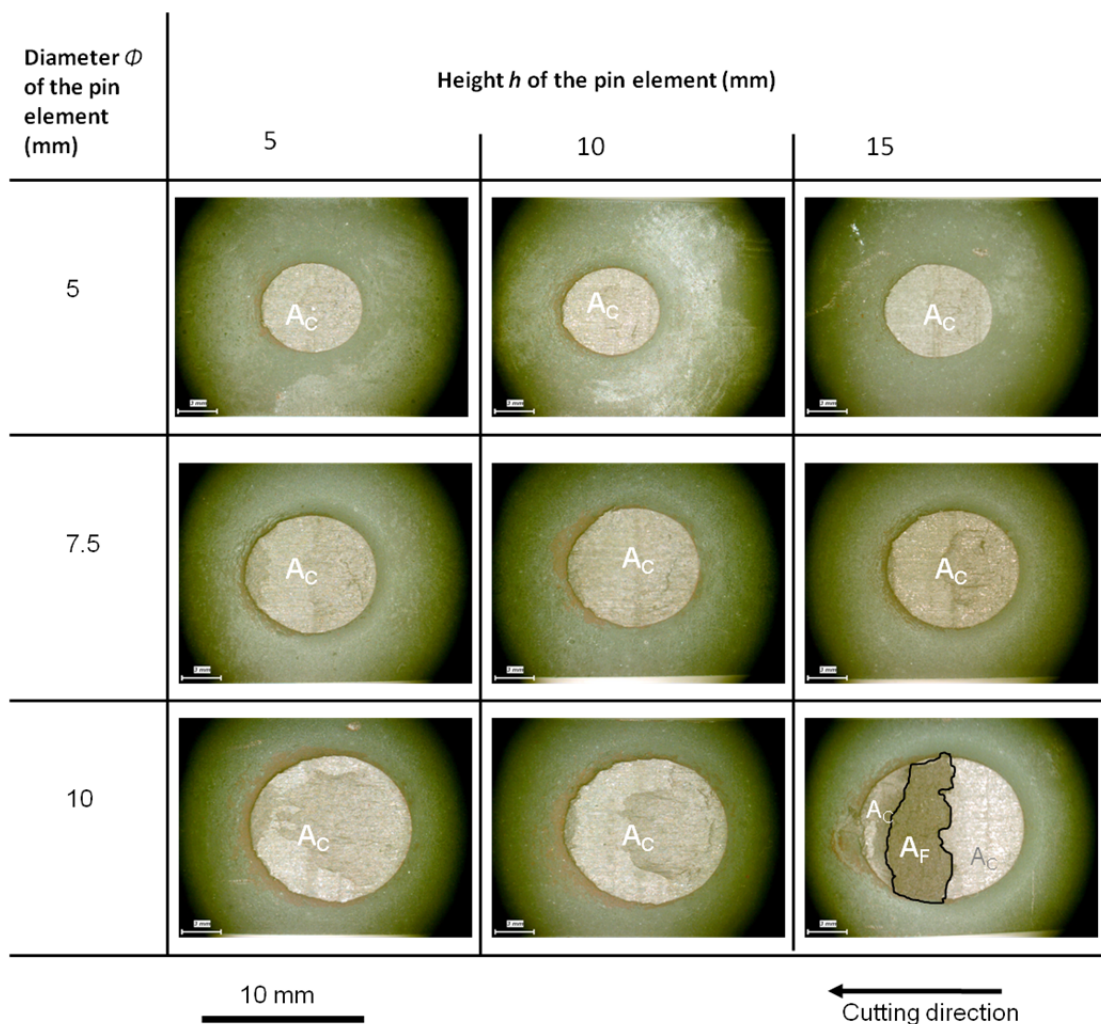
Corresponding specimens cut surfaces are shown in figure 7 for different dimensional conditions. The fractured area ( $A_F$ ) occurs only for the specimen with a pin height of 15mm and a pin diameter of 10mm (as identified above Fig. 6, specimen named  $1.6 \text{ m.s}^{-1} \text{ } -10^\circ$ ).

Figure 7. Optical views of specimen cut faces after hot cutting tests (Cutting speed= $1.6 \text{ m.s}^{-1}$ ; tool rake angle  $=-10^\circ$ ) versus to the pin heights and diameters tested. Cut and Fractured areas are respectively named  $A_C$  and  $A_F$ .

Finally, one can observe that the generation of a damaged cut surface is only activated by the combinations of several penalizing parameters: negative (or null) rake angle of the tool; cutting speed  $\geq 1.6\text{m}\cdot\text{s}^{-1}$ ;  $\phi \geq 10\text{ mm}$ ;  $h \geq 15\text{ mm}$ .

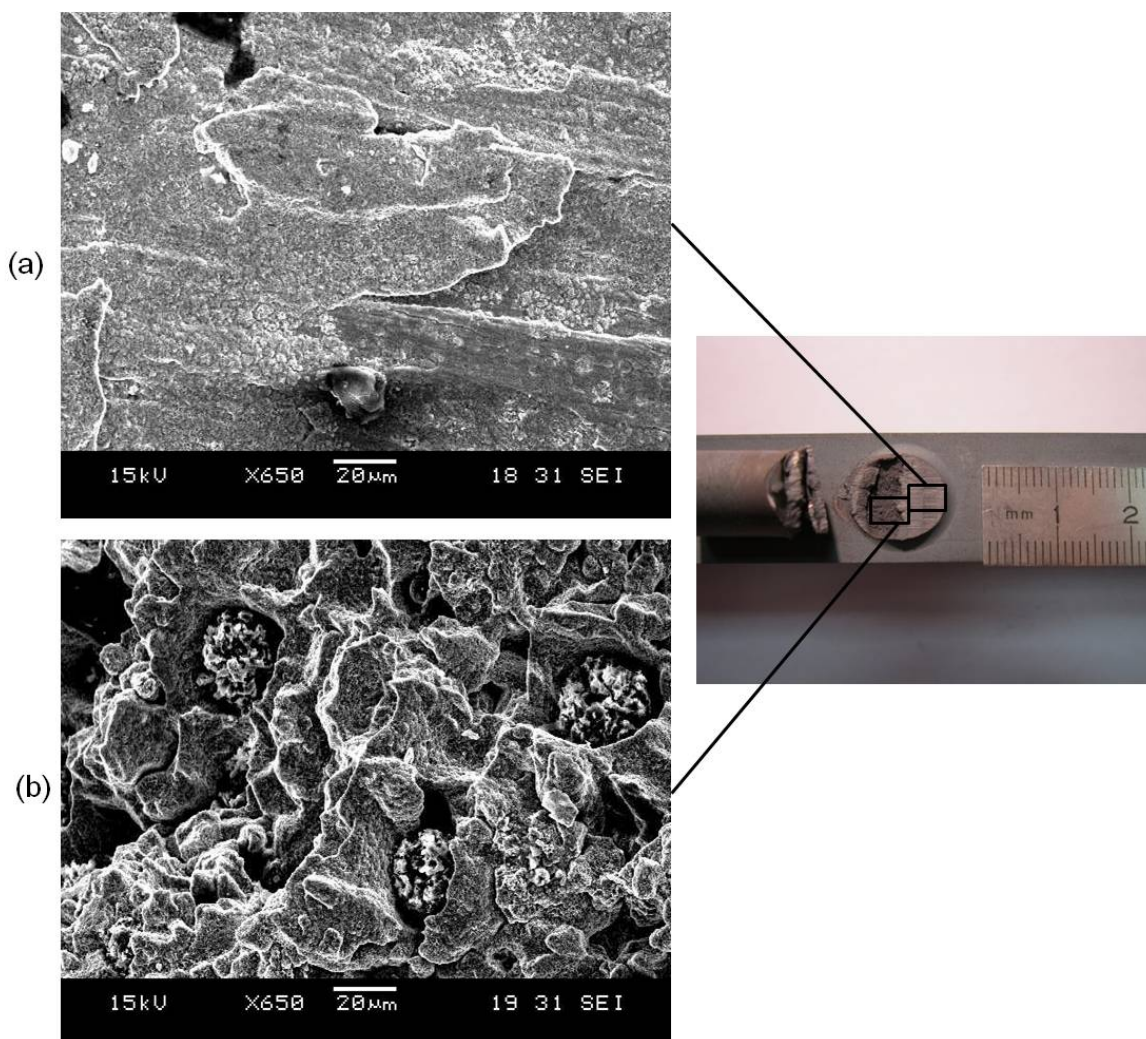
In order to understand the physical mechanisms involved in the generation of both  $A_C$  and  $A_F$  regions, SEM observations have been made. They can be seen on figures 8 and 9. The  $A_C$  region shows a flat cut surface without any deep damage. On the contrary, the  $A_F$  area shows a brittle fracture which results from micro-cracks associated with the graphite-matrix interface that surround the spherical nodules and then propagate to the matrix.

Figure 8. SEM details views of the  $1.6\text{ m}\cdot\text{s}^{-1}$   $-10^\circ$  specimen cut face in (a) the cut area ( $A_C$ ) ; (b) the fractured area ( $A_F$ ).  
[Cutting speed =  $1.6\text{m}\cdot\text{s}^{-1}$ ; rake angle =  $-10^\circ$ ;  $h=15\text{mm}$  and  $\phi=10\text{mm}$ ].

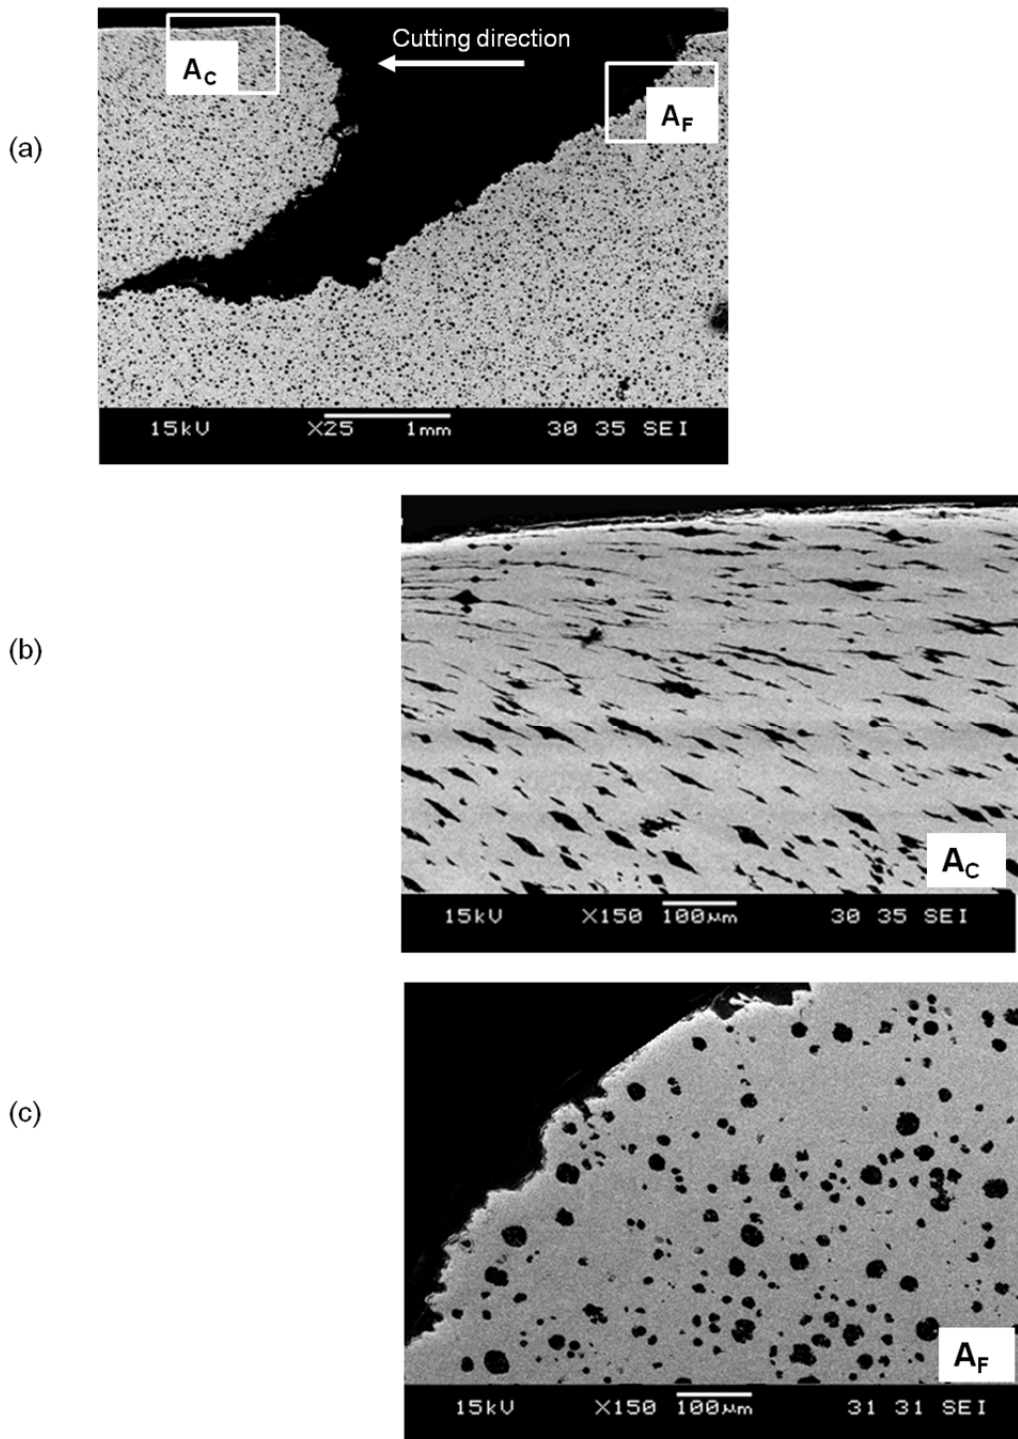
Cross section micrographic views of the same specimen ( $1.6 \text{ m.s}^{-1}$   $-10^\circ$ ) are shown on figure 9 (a) where graphite nodules are highlighted without any chemical etching.

Figure 9. Cross section SEM view of  $1.6 \text{ m.s}^{-1}$   $-10^\circ$  specimen with deep cracking damage (8(a)). Microstructural details of the  $A_C$  area (8(b)) and the  $A_F$  area (8(c)). [Cutting speed =  $1.6 \text{ m.s}^{-1}$ ; rake angle =  $-10^\circ$ ;  $h=15\text{mm}$  and  $\phi=10\text{mm}$ ].

In the  $A_C$  zone (figure 9(b)), highly elongated graphite nodules parallel to the cutting direction are observed. On the contrary, in the fractured area  $A_F$ , no change can be noticed from the original

nodules shape (figure 9(c)). This suggests a brittle fracture in  $A_F$  whereas  $A_C$  shows a large plastic deformation of the nodules consistent with a ductile shear mode.

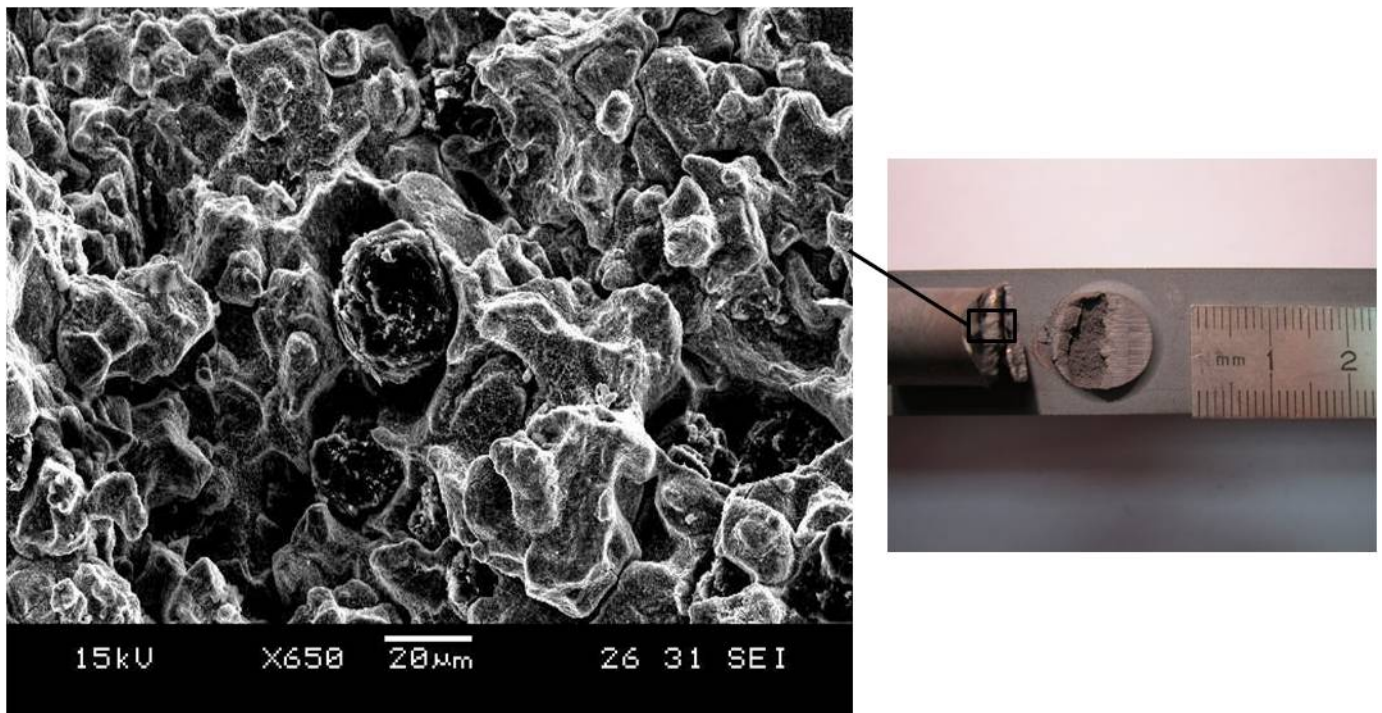
The analysis of the “Chip-Pin” face corresponding to the  $A_F$  cut surface is illustrated in figure 10. A decohesive rupture surface can be observed where the graphite nodules interface acts as crack initiation sites.

Figure 10. SEM views of  $1.6\text{m}\cdot\text{s}^{-1}_{-10^\circ}$  specimen “Chip-Pin” cut face. [Cutting speed =  $1.6\text{ m}\cdot\text{s}^{-1}$ ; rake angle =  $-10^\circ$ ;  $h=15\text{mm}$  and  $\phi=10\text{mm}$ ].

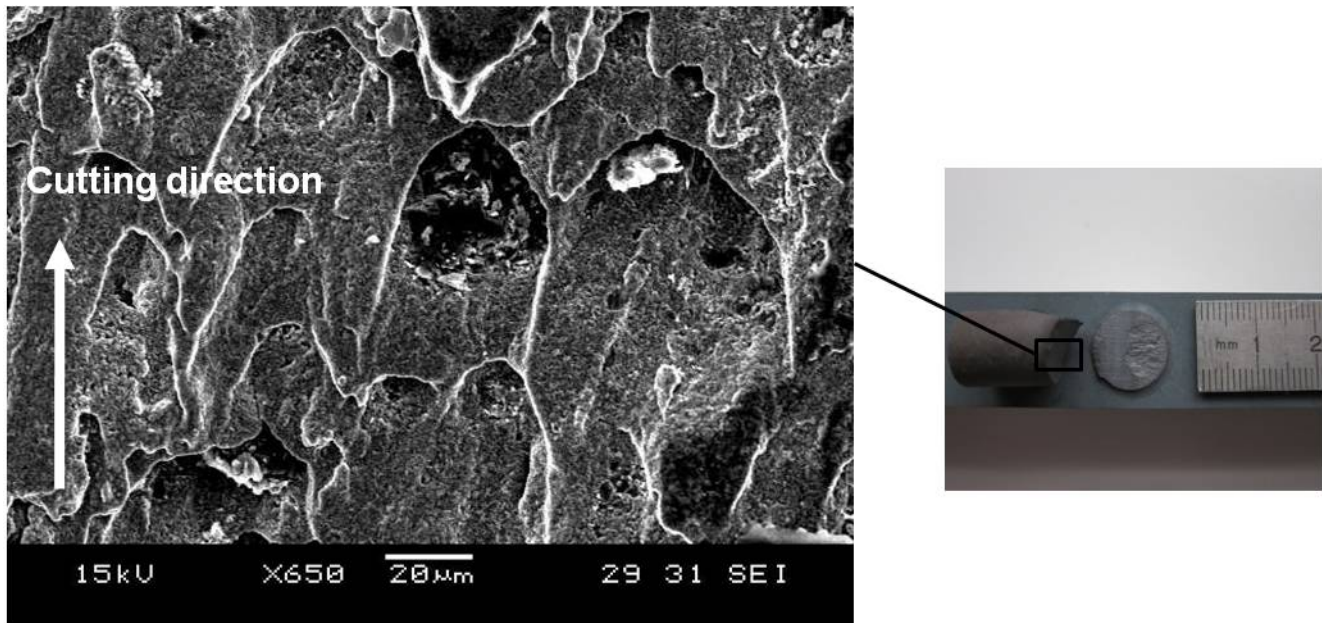
For comparison, a “Chip-Pin” cut without any deep damage ( $1.3\text{m}\cdot\text{s}^{-1}_{-10^\circ}$  specimen for example) has been observed. It indeed shows a cut surface oriented in the direction of maximum shear stress (cutting direction) with elongated dimples showing cup-cone ductile fracture pattern (figure 11).

Figure 11. SEM views of  $1.3\text{m}\cdot\text{s}^{-1}$   $-10^\circ$  specimen “Chip–Pin” cut face. [Cutting speed =  $1.3\text{m}\cdot\text{s}^{-1}$ ; rake angle =  $-10^\circ$ ;  $h = 15\text{mm}$  and  $\phi = 10\text{mm}$ ].

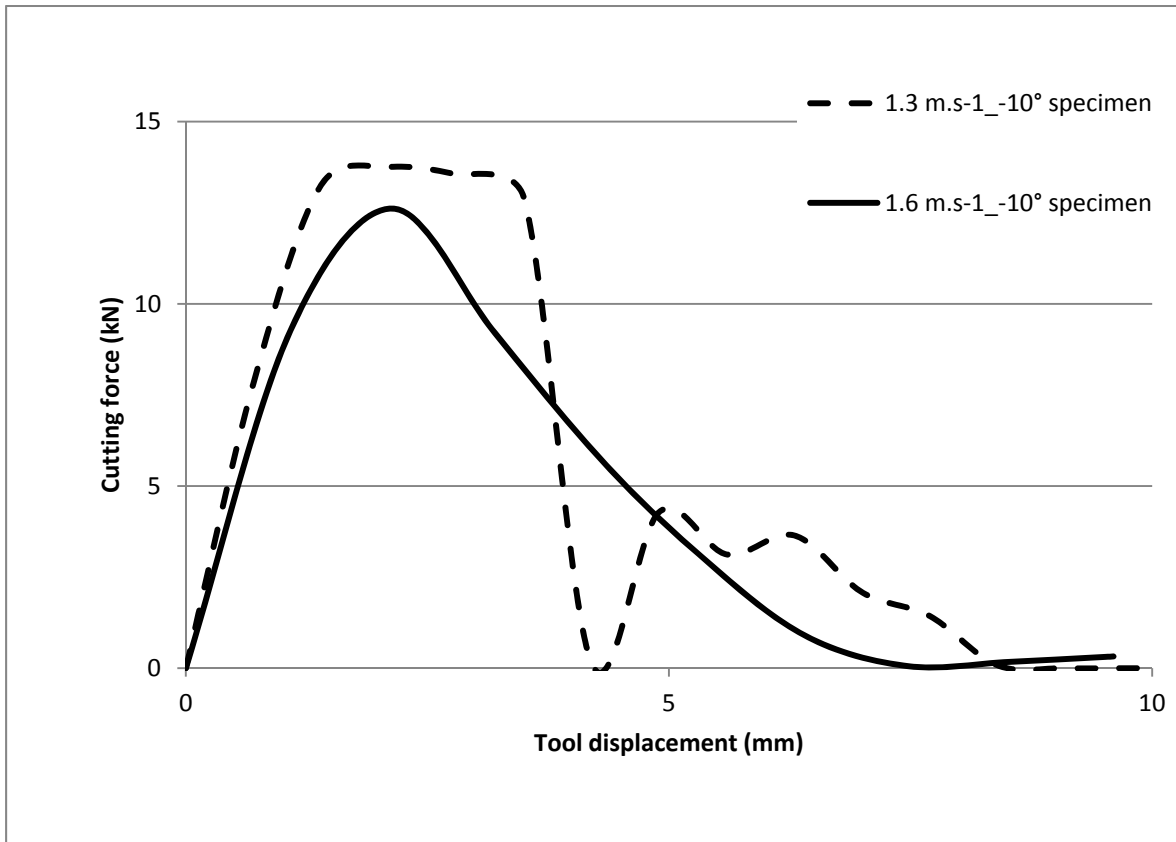
The cutting force curves versus the tool displacement are shown in figure 12 for the tests made on both previous compared specimens ( $1.3\text{m}\cdot\text{s}^{-1}_{-10^\circ}$  and  $1.6\text{m}\cdot\text{s}^{-1}_{-10^\circ}$  ones).

Figure 12. Experimental cutting force-displacement curves for both  $1.3\text{ m}\cdot\text{s}^{-1}_{-10^\circ}$  and  $1.6\text{m}\cdot\text{s}^{-1}_{-10^\circ}$  specimens. [ $h = 15\text{mm}$  and  $\phi = 10\text{mm}$ ].

The reported results (Fig. 12), representative for a large number of similar tests, state the following specific information:

- The “Chip-pin” element is removed from the specimen after a short tool displacement  $d$  ( $\leq 0.5\phi$ );
- The curve recorded for a specimen presenting a large fractured area ( $1.6\text{m}\cdot\text{s}^{-1}_{-10^\circ}$  specimen) reaches a peak of a maximum value before coming down smoothly to zero;
- The curve obtained for a specimen without any fractured area ( $1.3\text{m}\cdot\text{s}^{-1}_{-10^\circ}$  specimen) reaches a plateau for a course of several millimeters ( $\approx 0.3\phi$ ) before falling down quickly to zero. The curve then shows some rebounds.

The dependence between the falling portion of the force-displacement curve and the presence or absence of the fractured area within the specimen cut surface may be explained by the brittle-ductile transition (BDT) taking place within the SG iron specimen at the hot temperatures.

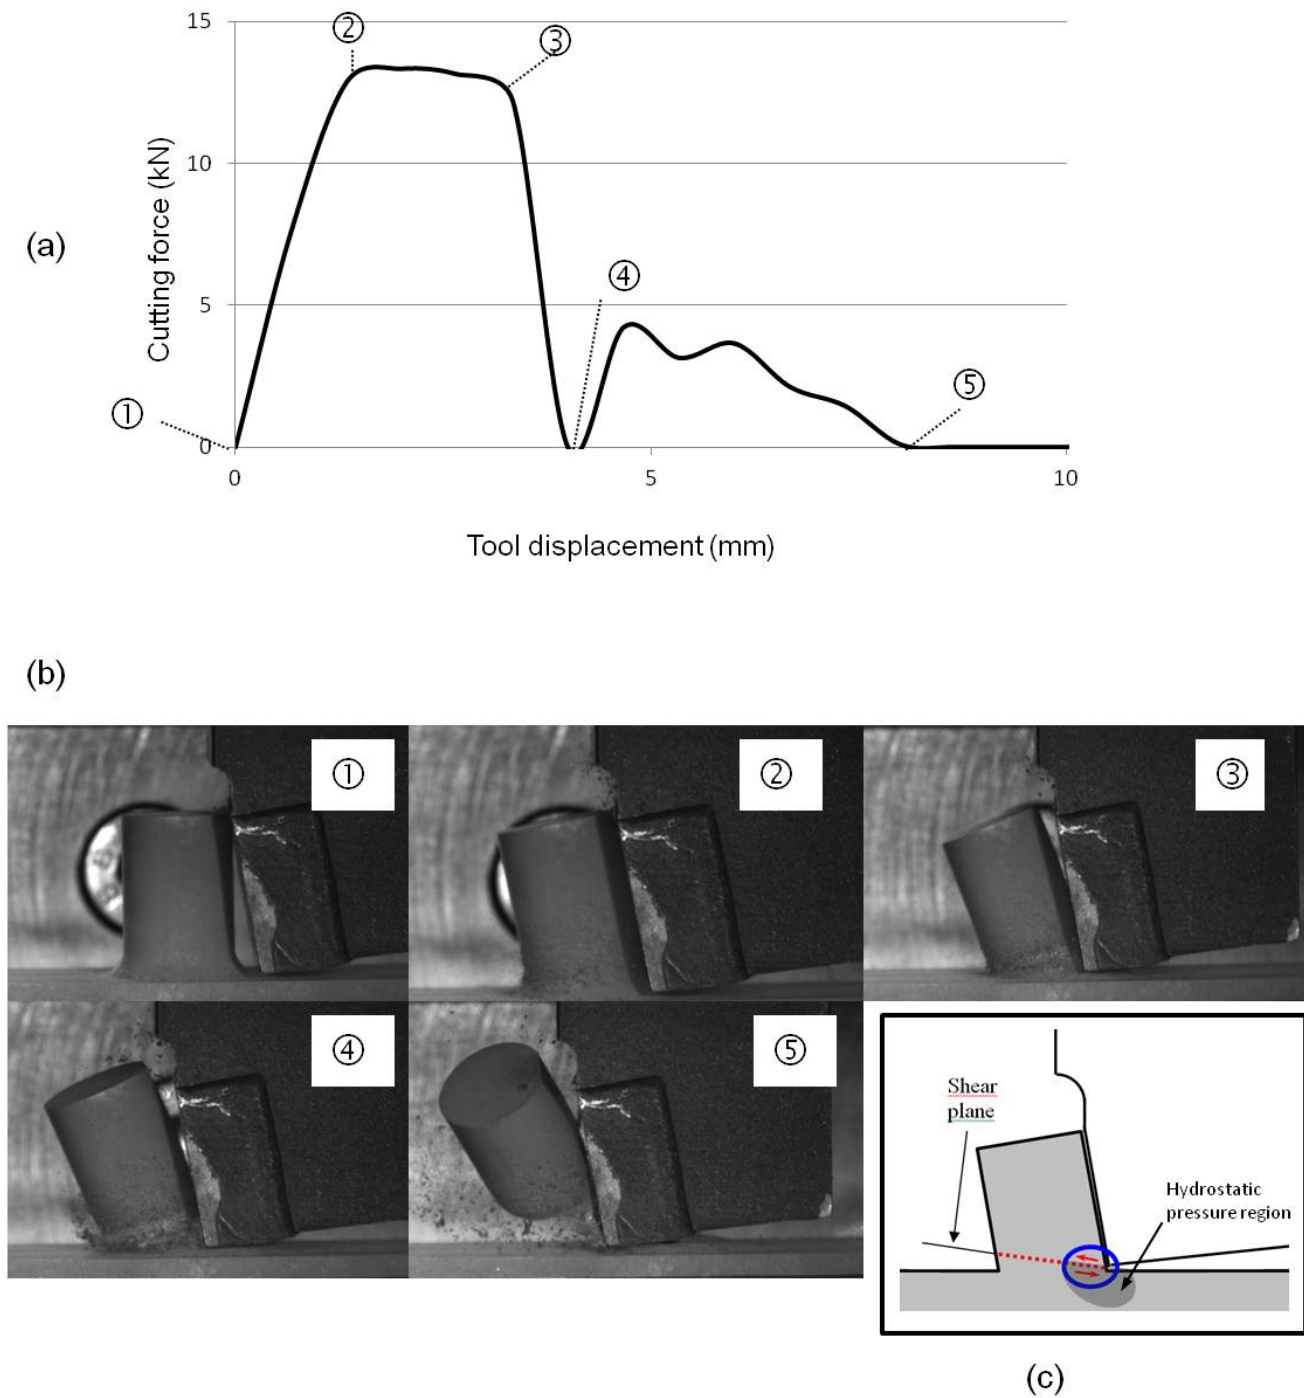
For the lowest cutting speed ( $1.3 \text{ m.s}^{-1}_{-10^\circ}$  specimen) a named Ductile-Shear Regime (DSR) governed by plastic deformation seems established: the shear stress on the shear plane increases as the tool is fed, until a sufficient value is reached to suddenly produce the fracture. Between the scenes ③ and ④ of figure 13 (b), the pin element is completely removed and ejected following a flat surface free of cracks. A schematic view of this phenomenon is illustrated on the figure 13 (c).

Figure 13. Views of hot cutting action for the  $1.3\text{m}\cdot\text{s}^{-1}_{-10^\circ}$  specimen (b) with corresponding cutting force data (a). Schematic view of the ductile-shear regime (DSR) governed by the plastic deformation occurring at the base of the “chip pin” element (c). [Cutting speed =  $1.3\text{m}\cdot\text{s}^{-1}$ ; rake angle =  $-10^\circ$ ;  $h = 15\text{mm}$  and  $\phi = 10\text{mm}$ ].

- Negative rake angle for the cutting tool should be avoided. As it will be shown in the figure 13 (pictures recorded by the high speed camera), a negative tool rake angle induces bending of the pin element that favors plowing rather than cutting with a brittle fracture and a deep damaging if the cutting speed is high enough ( $\geq 1.6\text{m}\cdot\text{s}^{-1}$ ). Avoiding negative rake angle allows solliciting the pin in pure shear with an undamaged cut surface.
- The cutting speed should be inferior to  $1.6\text{m}\cdot\text{s}^{-1}$ : the influence of this parameter will be discussed more specifically in the remaining sections of this paper.
- The pin geometry should be such as  $h < 15\text{mm}$  and  $\phi < 10\text{mm}$ .

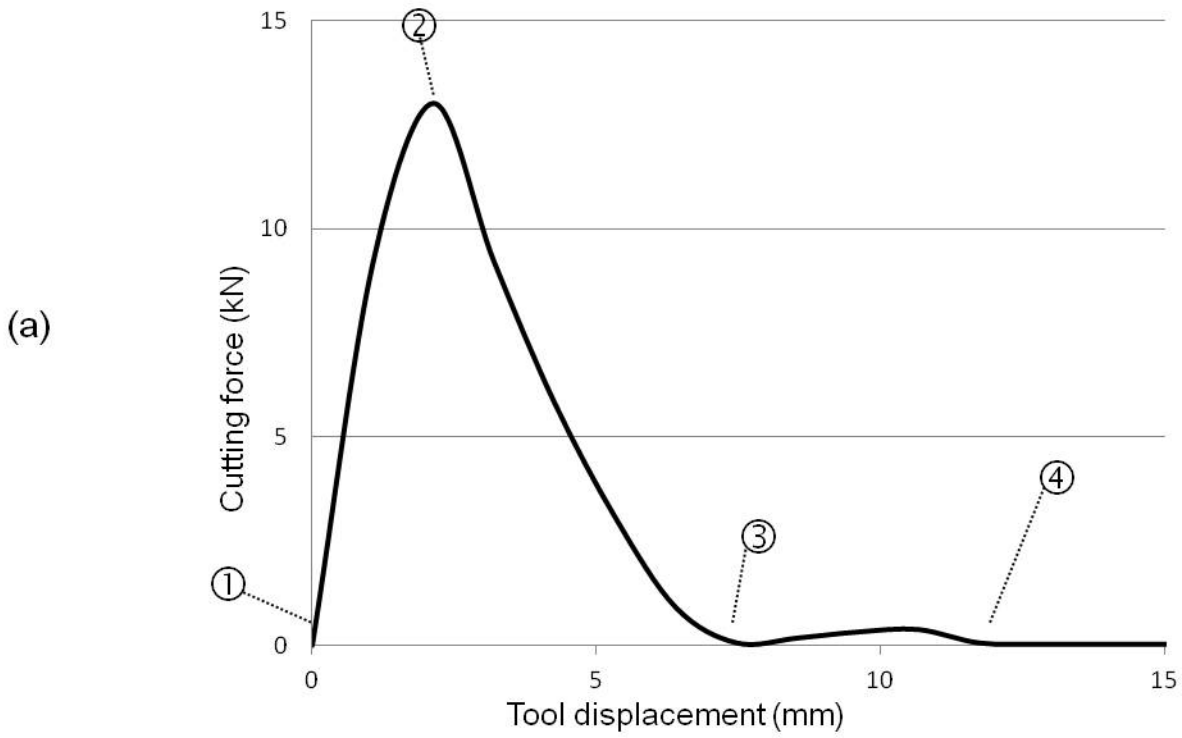
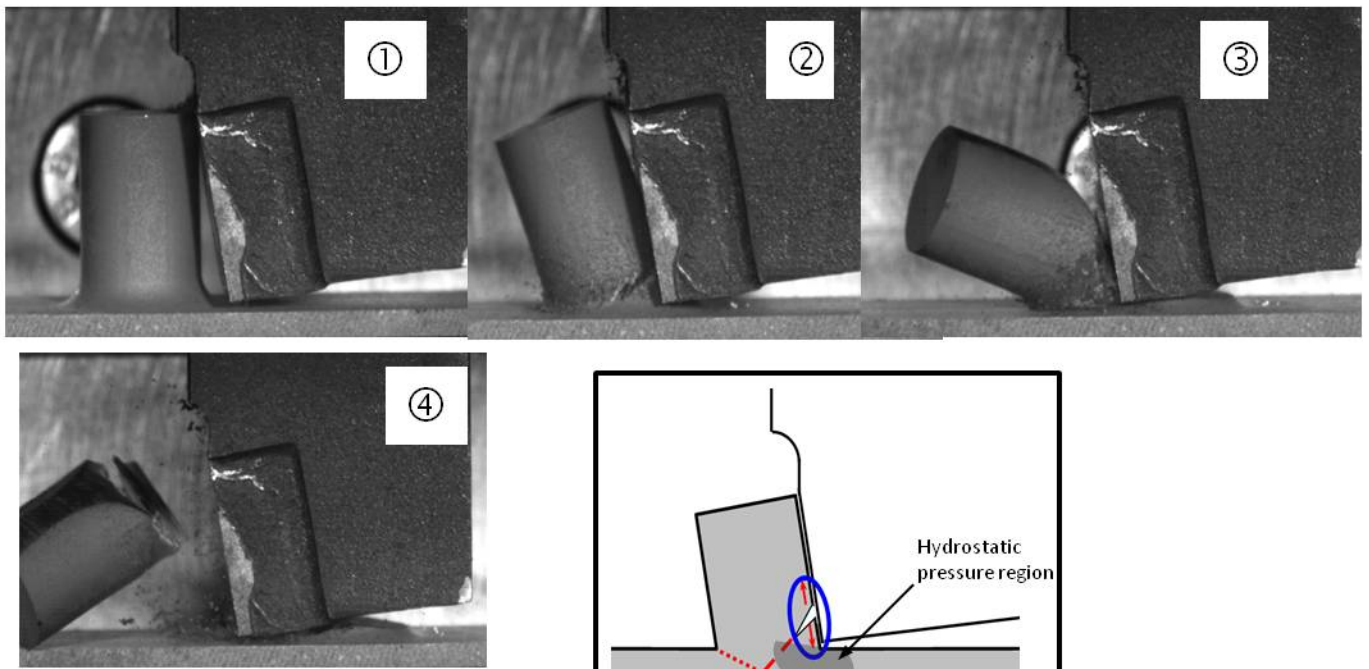
As the cutting speed increases to  $1.6\text{ m/s}$  ( $1.6\text{m}\cdot\text{s}^{-1}_{-10^\circ}$  specimen), the pin element is rather extruded between the tool and the specimen free surface (figure 14). During this extrusion, the “Chip-pin” element does not slide along the tool face but is rather pushed down. A named Brittle-Cracking

Regime (BCR) governed by the brittle deformation mode is rather established: an initial crack is formed within the pin base in the vicinity of the cutting edge where high tensile normal stresses take place. The fracture occurs with consequent surface and subsurface brittle damages before a short shearing process starts (see schematic view in figure 14(c)). In such a combination of a high cutting speed (a high implied strain rate) and an hydrostatic pressure field caused by negative rake angle, the energy required to propagate cracks is believed to be lower than the energy required for plastic deformation, so that brittle-cracking regime is the predominant mechanism of the material removal.

Figure 14. Views of hot cutting action for the  $1.6 \text{ m.s}^{-1}_{-10^\circ}$  specimen (b) with corresponding cutting force data (a). Schematic view of the brittle-cracking regime (BCR) governed by the brittle deformation of the “chip pin” element (c). [Cutting speed =  $1.6 \text{ m.s}^{-1}$ ; rake angle =  $-10^\circ$ ;  $h = 15\text{mm}$  and  $\phi = 10\text{mm}$ ].

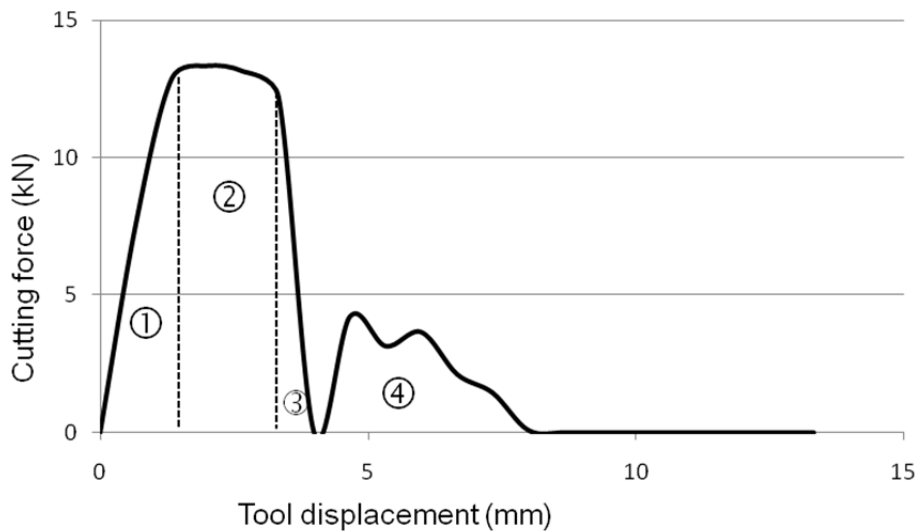
Figure 15. Typical cutting force-displacement curve for ductile-shear regime. [ $1.3 \text{ m}\cdot\text{s}^{-1}$   $-10^\circ$  specimen i.e. Cutting speed =  $1.3 \text{ m}\cdot\text{s}^{-1}$ ; rake angle =  $-10^\circ$ ;  $h = 15\text{mm}$  and  $\phi = 10\text{mm}$ ].

- Stage ① corresponds to an elastic behavior of the material under the tool solicitation;
- Stage ② corresponds to the material plastic deformation by ductile shear. The cutting force rises to a plateau for a more or less short tool displacement according to the cutting speed tested (Fouilland and El Mansori, 2010);
- At the stage ③, the “Chip-pin” is broken free from the specimen along a shear plan. The cutting force falls suddenly to zero;
- Stage ④ reveals the shaping of the remaining excess metal with small thickness.

The existence of a fractured area within the cut surface is now directly related to the brittle behavior (BCR) without any plastic deformation stage identified from the force-displacement curve. On the contrary, a crack-free cut surface is associated to the ductile regime (DSR) with a large ductile deformation stage by shear (stage ② on figure 15).

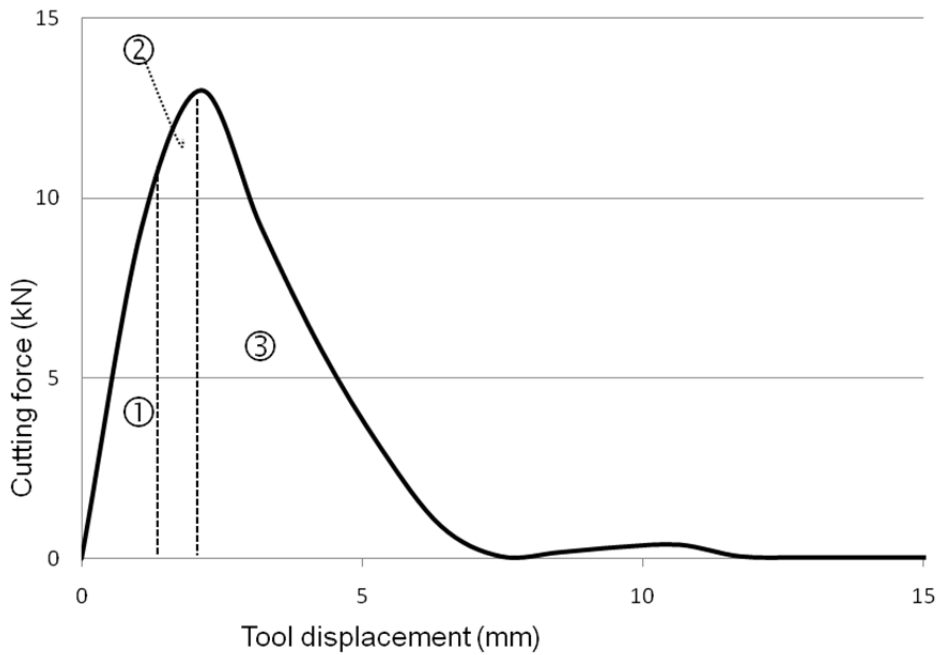
On the contrary, typical stages of the brittle-cracking regime (BCR) are shown in figure 16. After stage ① (elastic behavior), a short crack stage takes place (stage ②) followed by simultaneous “Chip-pin” ejection and shaping of the remaining excess thickness (Stage ③).

Figure 16. Typical cutting force-displacement curve for brittle-cracking regime. [ $1.6 \text{ m.s}^{-1}$   $-10^\circ$  specimen i.e. Cutting speed =  $1.6 \text{ m.s}^{-1}$ ; rake angle =  $-10^\circ$ ;  $h = 15\text{mm}$  and  $\phi = 10\text{mm}$ ].
