Laurence FOUILLAND-PAILLE, Mohamed EL MANSORI - Experimental study of the brittle–ductile transition in hot cutting of SG iron specimens - Journal of Materials Processing Technology - Vol. 213, n°2, p.201-213 - 2013

# Experimental study of the brittle–ductile transition in hot cutting of SG iron specimens

The present paper investigates the brittle-ductile transition (BDT) of the primary shear zone during cutting of spheroidal graphite (SG) iron in the austenitization temperature range (around 1000 °C). The experimental tests were performed using a cutting test bench in the cutting speed range of 0.8 to 1.6m.s<sup>-1</sup>. The cut surfaces were studied using optical microscopy and Scanning Electron Microscope (SEM) analysis techniques. The obtained results revealed either consequent deep fractured regions governed by a brittle-cracking regime (BCR) or a crack-free cut surface governed by a ductile-shear regime (DSR) with large plastic deformations.

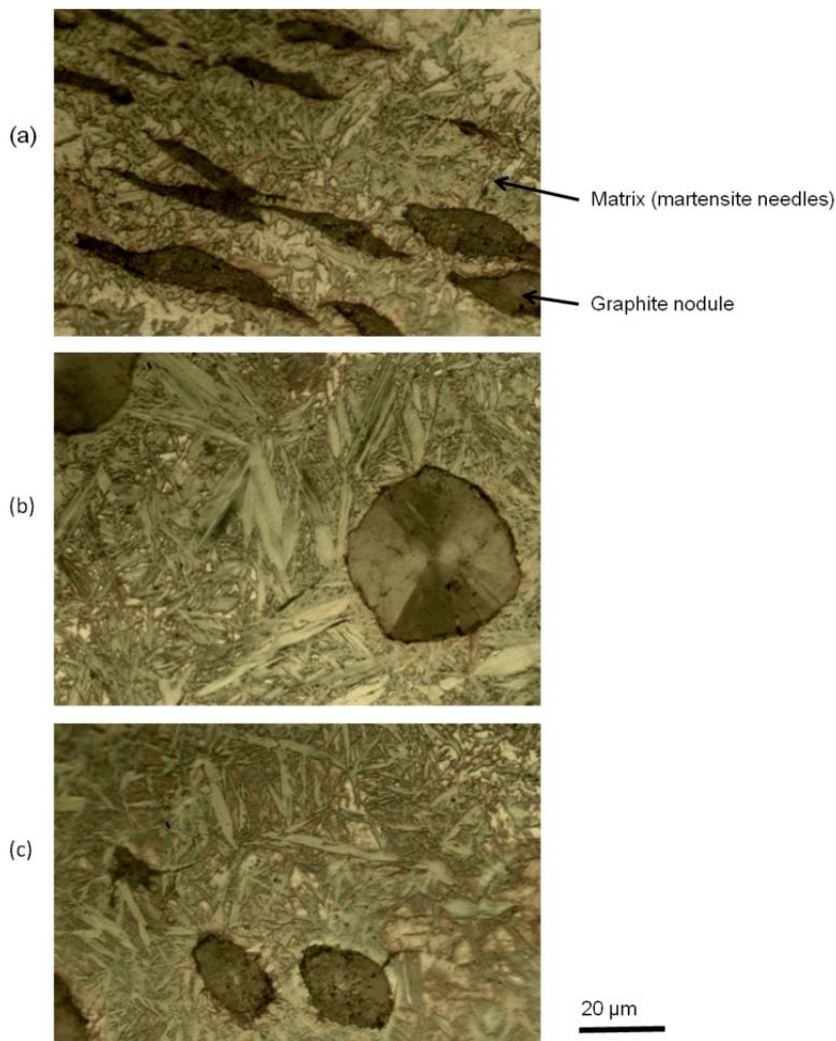
Figure 17. Cross section microstructural details after oil quenching.

(a) sub cut-surface of the  $1.3 \text{ m.s}^{-1}_{-10^\circ}$  specimen, (b) far away from the cut surface of the  $1.3 \text{ m.s}^{-1}_{-10^\circ}$  specimen, (c)  $1.6 \text{ m.s}^{-1}_{-10^\circ}$  specimen just below ( $A_F$ ) region. [Etched with supersaturated nitric acid].

The observed cross sectional surface of the  $1.3 \text{ m.s}^{-1}_{-10^\circ}$  specimen shows that martensite needles just below the cut surface are finer (figure 17-a) and shorter than these observed far away from the cut surface (figure 17-b). Concerning the  $1.6 \text{ m.s}^{-1}_{-10^\circ}$  specimen cut surface (i.e. just below the

fractured region ( $A_F$ )), no needles refinement was found (figure 17-c). According to Dragos et al. (1978), and as mentioned above, the fineness of the needles depends on the austenite grains size from which they originate and is thus a valid indicator of the dynamic recrystallization activation. This allows asserting that the dynamic recrystallization phenomenon is activated at the vicinity of the cut surface only for the  $1.3 \text{ m.s}^{-1}_{-10^\circ}$  specimen. For the  $1.6 \text{ m.s}^{-1}_{-10^\circ}$  specimen the cutting speed seems high enough to prevent this phenomenon. As a consequence, this metallographic study gives confidence in the previous results and indicates that the dynamic recrystallization is the main origin of the BDT in SG hot cutting process.

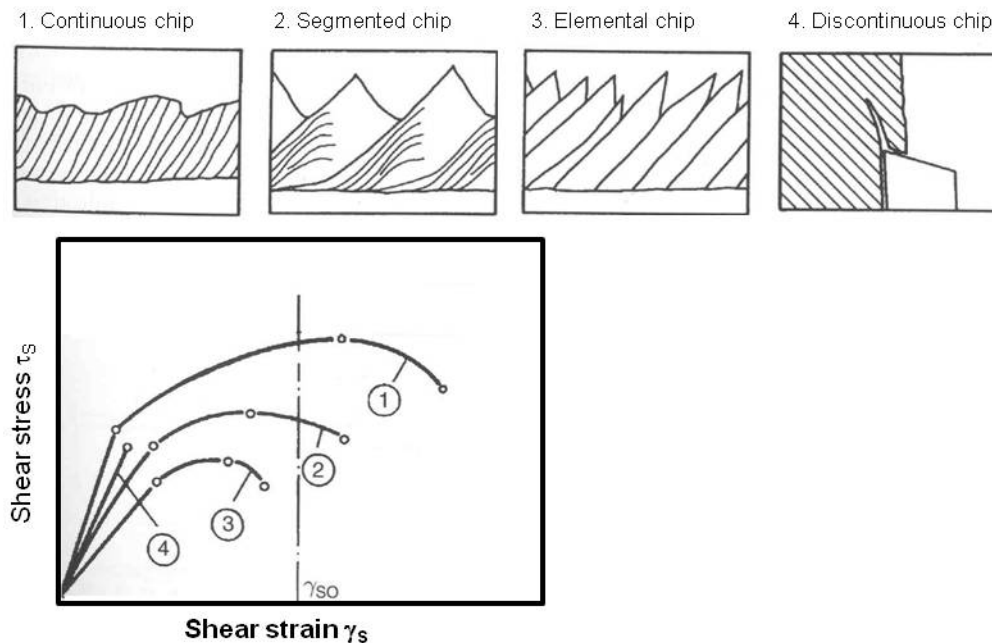
The chip-pin formation mechanisms in the primary shear zone may be explained regarding the well-known underlying chip formation mechanisms and material deformation behavior. Concerning machining with a flat-faced tool, Grzesik (2008) explains the formation of usually called discontinuous and shear-types chips using the appropriate stress/strain curve as follows (figure 18):

Figure 18. Chip formation mechanisms in terms of stress/strain curves [Grzesik (2008)].

Discontinuous chips are formed when machining brittle materials or materials containing point of stress concentration. Fracture occurs when material undergoes only elastic deformation (curve 4) and a crack propagates from the cutting edge to the free surface. When materials have sufficient

ductility, the formation of a continuous or a segmented (also called saw-tooth) chip takes place, which generally results in a good surface finish. Continuous chips are related to curve 1 with large plastic flow of the material and characteristic neck of a tensile specimen developed after the critical value of shear strain  $\gamma_{SO}$ . If the plastic flow is not so intensive and shear strain exceeds slightly  $\gamma_{SO}$ , the onset of chip segmentation is observed (partially segmented chip vs curve 2). During rapid plastic deformation (as speed increases), the chip segmentation starts to develop until complete separation (elemental chip vs curve 3). In this case, the material necks before fracture but at relatively lower shear stress. It should be noted that all three latter types of chips are formed by shearing mechanisms and are related to the plastic deformation of ductile work materials.

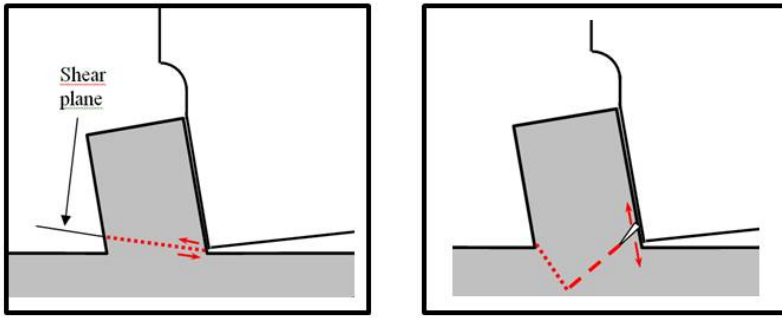
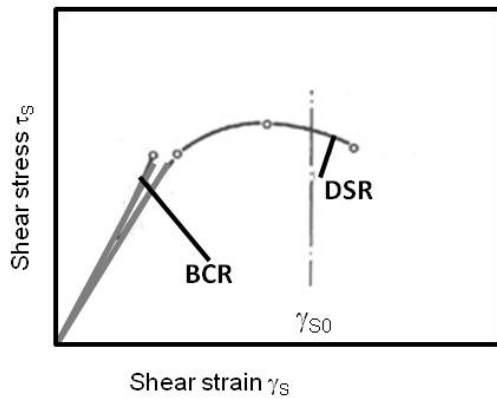
In the present study, when the strain softening resulting from dynamic recrystallization is more pronounced than the associated strain-hardening, a ductile shear regime (DSR) takes place (figure 19 vs curve DSR) and the pin element is completely sheared (ductile sheared chip-pin in figure 19) following a flat shear surface in analogy with the segmented chip formation mechanism. The discontinuous chip formation mechanism described by Grzesik (2008) may also aid the brittle cracked chip-pin mechanism comprehension (figure 19 vs curve BCR) when the pin fracture occurs without any plastic deformation.

Figure 19. Chip-pin formation mechanisms in terms of stress/strain curves (BCR=Brittle Cracking Regime, DSR=Ductile Shear Regime).
