Vanessa RODRIGUEZ, Jacob SUKUMARAN, Yeczain PEREZ DELGADO, Mariana STAIA, Alain IOST, Patrick DE BAETS - Scratch evaluation on a high performance polymer - Mechanical Engineering Letters - Vol. 9, p.76-84 - 2013

# Scratch evaluation on a high performance polymer

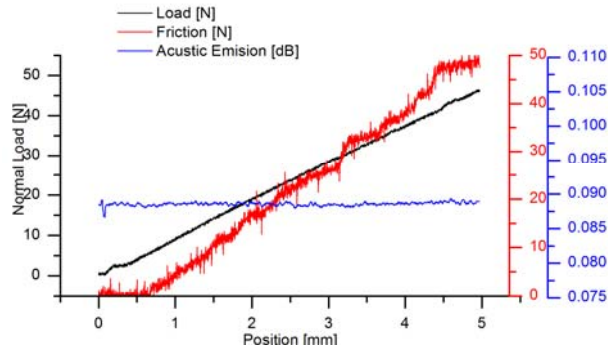
Figure 2. Typical course of the scratch loads versus scratch length measure in PEEK-E02 with a progressive load of 50N

Various properties were observed in this study such as penetration depth, tangential force, surface damage as a function of load, there are plotted in the figure 2 and 5 for the two PEEK filled with composites were shows the experimental results of scratching test. In both figure, it can be observed that the scratch force is increased as the load increased. From the Coulomb's law, it is evident that there is a linear relationship between scratch force and applied load. In previous investigations by Sujeet Sinha (Sinha and Lim 2006) founds that the scratch forces for all polymers that their investigated such as polypropylene,

The figure 2 is a typical testing curve for polymers under progressive load scratch test of the PEEK-E02 sample, where the tangential force curves show small magnitude of fluctuations at the beginning and at the middle of the test due to the inertial effects of instantaneously accelerating the scratch head to the designated scratch speed. But after this, the tangential force increase slightly and in a digressive manner to its final level, influences at the end by the movement of the indenter.

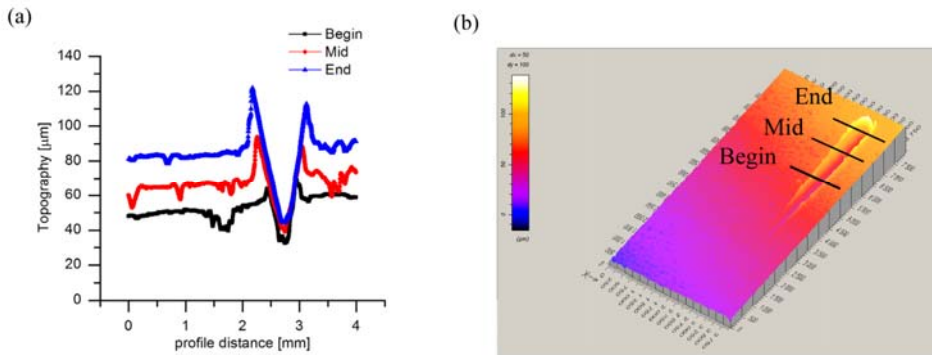
Figure 3. Profilometer results of a typical scratch on a PEEK-E02 surface: (a) depth profile with clear evidence of the scratch with different positions of the scratch; beginning, middle and end (b) 3D view of the scratch test

An evaluation of the scratch produced using profilometry leads to the profiles shown in figure 3 (a) the penetration depth with less material deformation at the beginning and a progressively increasing residual scratch towards the end of the scratch. At this position the scratch depth is also slightly deeper from the normal scratch course, due to the back-movement of the scratch head. In the figure 3(b) a corresponding a 3D view of the scratch following the original scratch direction, so that the deeper valley and the pushed-up hills at the rim of the scratch are more visible.

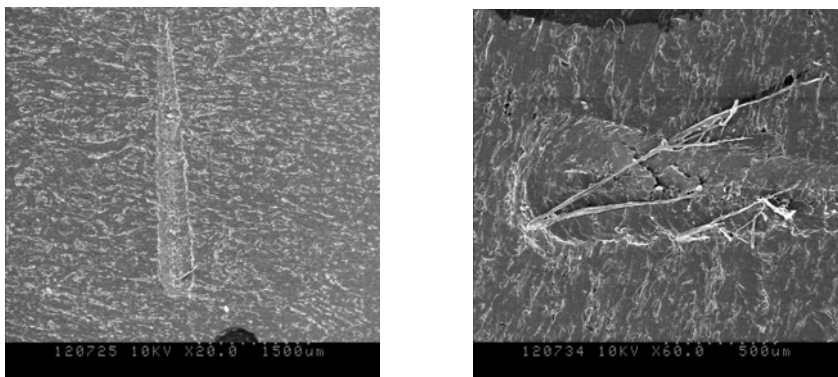
*Figure 4.* The scratch surface damage observed using scanning electron micrographs on PEEK-E02 under the scratching load of 50N and scratching velocity of 10mm/min

Additionally a few analysis of scanning electron microscopy images for the PEEK-E02 polymer figure 4 and figure 7 for PEEK-S01, were performed to understand how material deformation and removal processes take place during scratching. This has indications in the understanding of abrasive wear process for polymers because abrasive wear mechanism takes places by hard asperities or loose debris particles.

In figure 4, the sample of PEEK polymer filled with carbon fibers, graphite fibers and PTFE shows that the surface deforms with the formation of noticeable cracks, microcracks, materials removal and some detached debris particles within the scratch zone for PEEK-E02 material. In some cases depending upon the type of the materials and the severity of the contact, the material deformation can take place around the scratch tip with or without wear debris formation (Rajesh and Bijwe 2005).

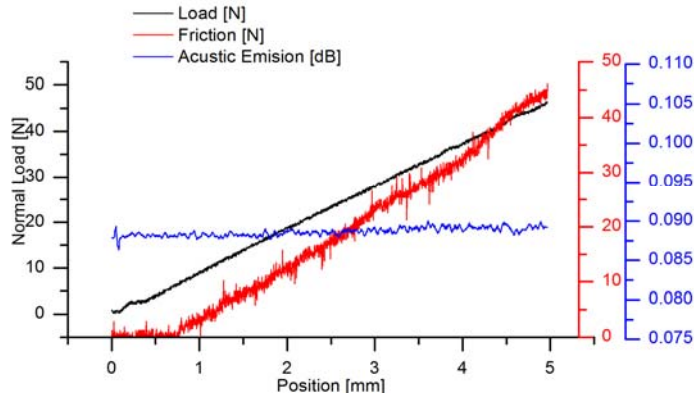
Figure 5. Typical course of the scratch loads versus scratch length measure in PEEK-S01 with a progressive load of 50N.

For the PEEK-S01 material filled with carbon fibers, graphite fibers shows smaller differences in the curve under the progressive load of the scratch test compared with the PEEK-E02 polymer as it can be seen in the testing curve under load scratch test figure 5, the appearance of the scratches on the both materials is rather similar but in this case with less fluctuations and smooth changes during the scratching test. The scratch frictional force, and contact zone size increased almost linearly with applied load.

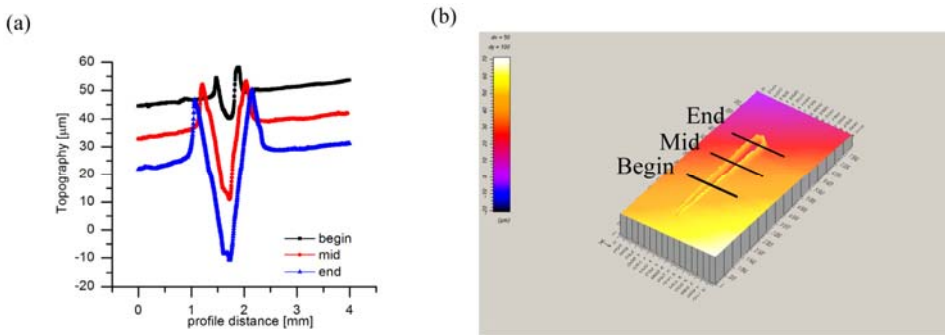
Figure 6. Profilometer results of a typical scratch on a PEEK-S01 surface: (a) depth profile with clear evidence of the scratch with different positions of the scratch; beginning, middle and end (b) 3D view of the scratch test.

The depth profilometry allows obtaining more precise information on the remaining penetration depth during scratching test. In the figure 6 (a) we can see the variation of the penetration in the bulk of polymer for the PEEK-S01 filled with carbon fibers and graphite it can be seen how is slightly deeper and smoothly in the beginning until the end of the scratch test. And it can be notice in the figure 6 (b) the 3D images and the penetration depth and the grooves formation during the scratching test in the material tested.

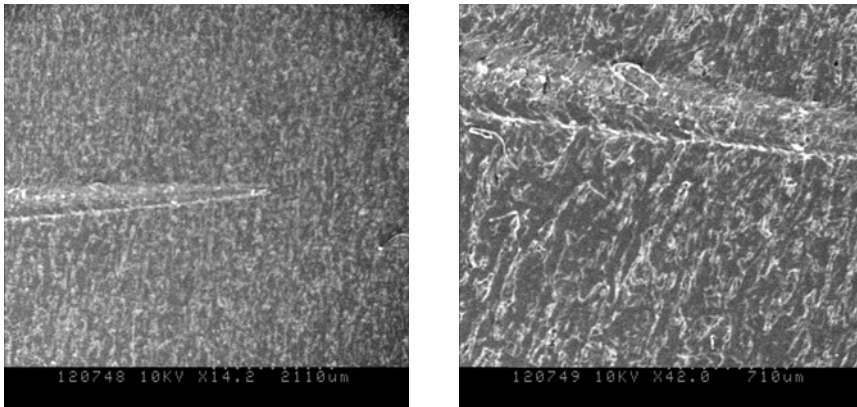
*Figure 7.* The scratch surface damage observed using scanning electron micrographs on PEEK-S01 under the scratching load of 50N and scratching velocity of 10mm/min

Also, by scanning electron microscopy (SEM) of the PEEK-S01 polymer in the figure 7 we can see the contour of the scratched surface when the load was further increased. The PEEK-S01 surface deforms with the formation of noticeable cracks within the scratch. A regular crack formation was seen, which can be due to surface stresses that the microstructure in the semi-crystalline polymer were subjected. Comparing SEM images of the PEEK-S01 with the

material PEEK-E02 it can be observed there is not clear formation of debris of the PEEK-S01 than in the SEM images of the PEEK-E02. A well-defined edge on the two sides of the scratch groove and a smooth scratch surface are formed after scratch pattern.
