Amine AMMAR, Benoit FURET, Guénaël GERMAIN, Yessine AYED - Tool wear analysis and improvement of cutting conditions using the high-pressure water-jet assistance when machining the Ti17 titanium alloy - Precision Engineering - Vol. 42, p.294-301 - 2015

Tool wear analysis and improvement of cutting conditions using the high-pressure water-jet assistance when machining the Ti17 titanium alloy

This paper presents experimental results concerning the machinability of the titanium alloy Ti17 with and without high-pressure water jet assistance (HPWJA) using uncoated WC/Co tools. For this purpose, the influence of the cutting speed and the water jet pressure on the evolution of tool wear and cutting forces have been investigated. The cutting speed has been varied between 50 m/min and 100 m/min and the water jet pressure has been varied from 50 bar to 250 bar. The optimum water jet pressure has been determined, leading to an increase in tool life of approximately 9 times. Compared to conventional lubrication, an increase of about 30% in productivity can be obtained.

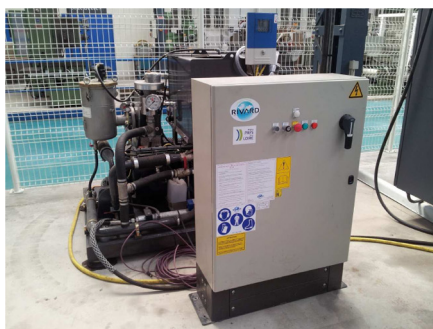
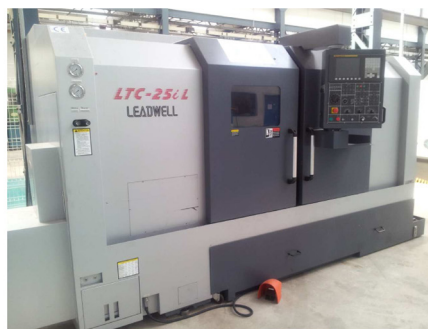
Fig. 2. (a) High-pressure pump, (b) CNC lathe.

All machining operations have been carried out with a “LEADWELL LTC25iL” CNC lathe (Fig. 2). A high-pressure pump has been used to supply the high-pressure jet (400 bar, 38 l/min). The pump tank is filled with 200 L of lubricant consisting of 95% water and 5% soluble oil. The experimental setup is illustrated by Fig. 3
